## INTRODUCTION

This book is a compilation and summary of data gathered by the Central Iowa Regional Association of Local Governments (CIRALG) in conjunction with the Iowa Division of Historic Preservation.

It contains the results of a survey conducted in 1979 of architecturally significant buildings in Ames. Similar surveys were conducted throughout the eight county CIRALG area, with 125 communities being canvassed.

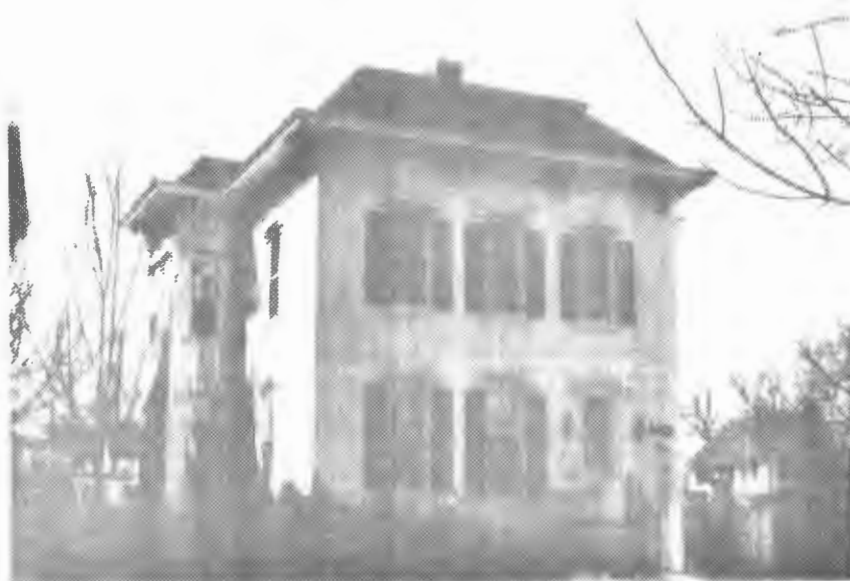
**THREATS TO STRUCTURE:** eave around West addition is rusting badly

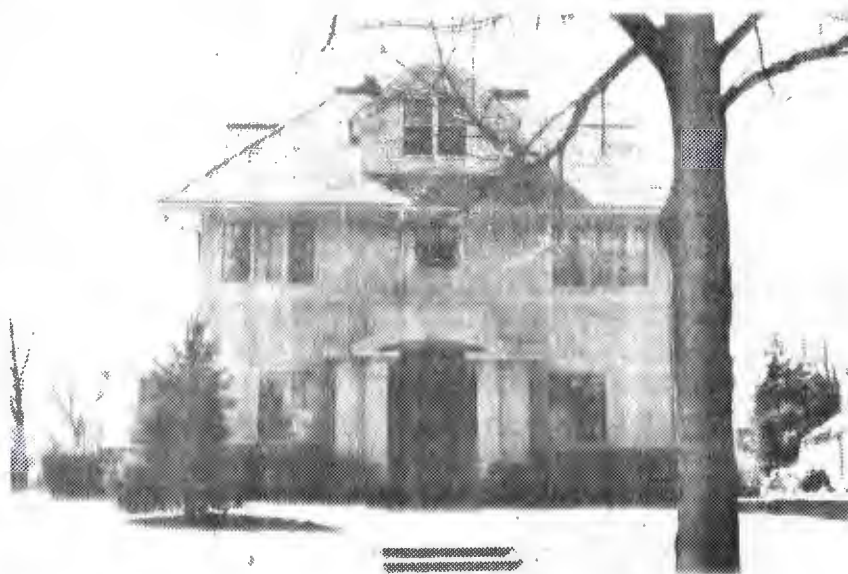
**THREATS TO STRUCTURE:** slight rusting on eave
