## INTRODUCTION

This book is a compilation and summary of data gathered by the Central Iowa Regional Association of Local Governments (CIRALG) in conjunction with the Iowa Division of Historic Preservation.

It contains the results of a survey conducted in 1979 of architecturally significant buildings in Ames. Similar surveys were conducted throughout the eight county CIRALG area, with 125 communities being canvassed.

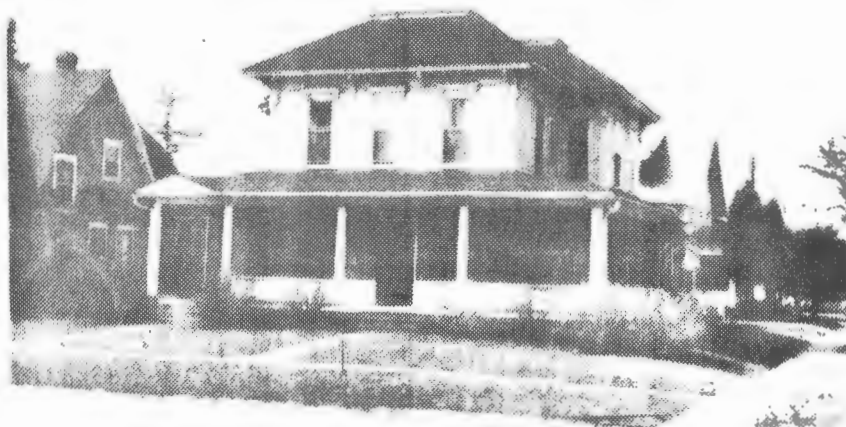
**THREATS TO STRUCTURE:** eave around West addition is rusting badly

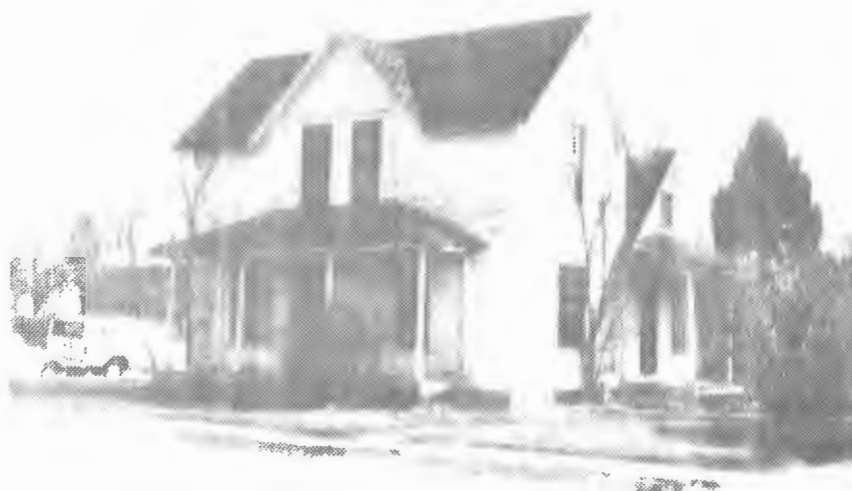
STREET ADDRESS: 622 Burnett Avenue

THREATS TO STRUCTURE: roof need repair

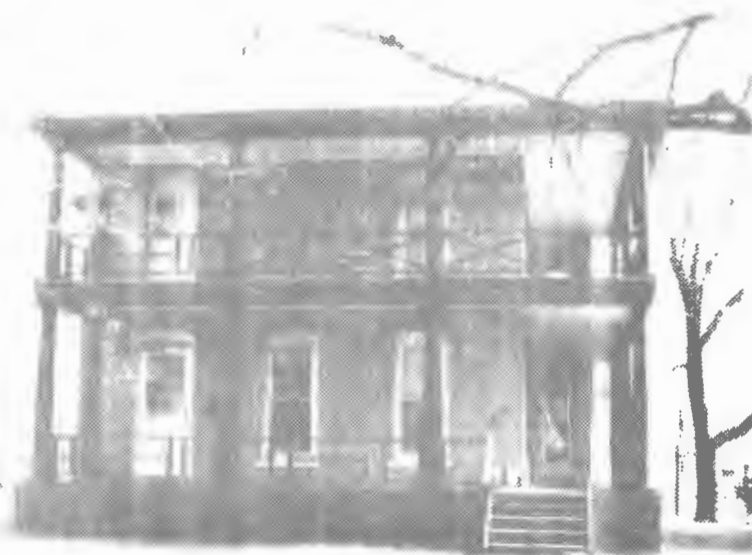
STREET ADDRESS: 522 Carroll  
 ORIGINAL USE: Residence  
 PRESENT USE: Residence (apartments)

THREATS TO STRUCTURE: gutter & eave in some need of repair

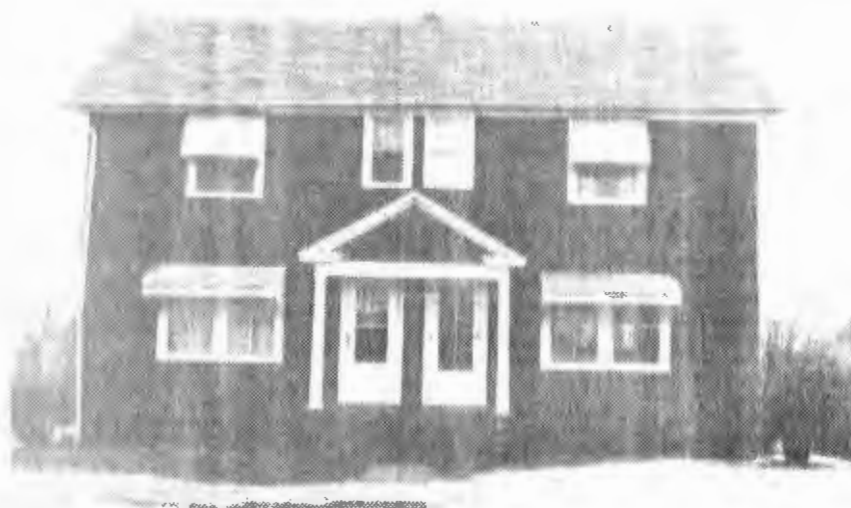
**STREET ADDRESS:** 616 - 618 Burnett Avenue

**THREATS TO STRUCTURE:** eave lines could use some repair

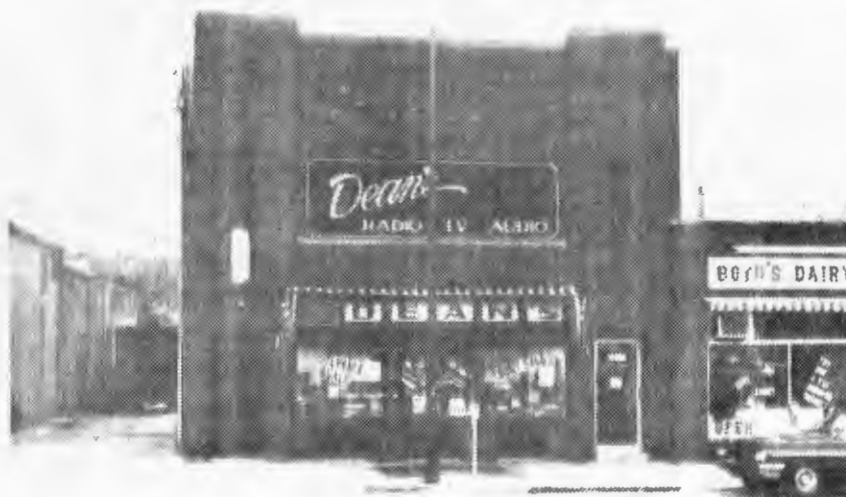
**STREET ADDRESS:** 108 Hayward Avenue  
**ORIGINAL USE:** Store - shops  
**PRESENT USE:** Dean's Radio & TV; above  
 book store

**ALTERATIONS, ADDITIONS:** one door replaced with aluminium door

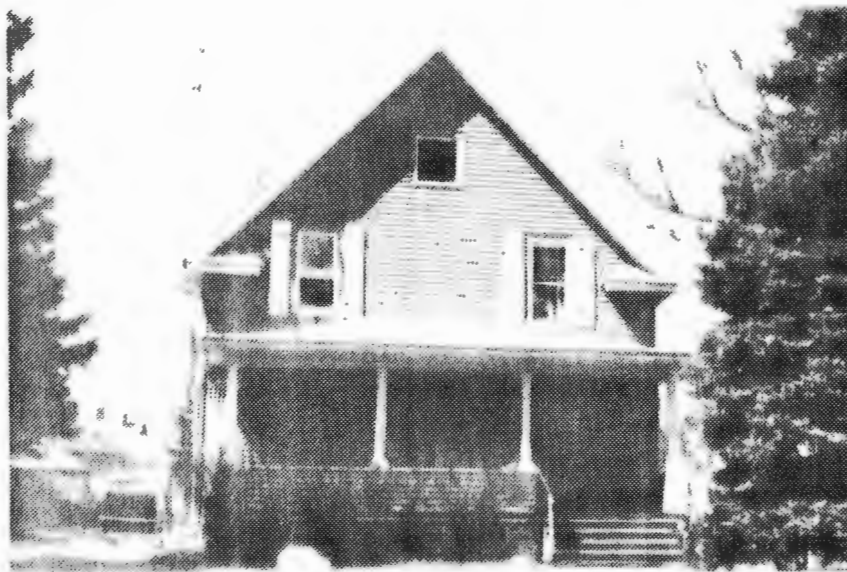
**COMMENTS:** gabled roof with cornice returns; broad, open porch wraps around S. and E. sides; Doric columns on porch; layered molding on lintels; decorative concrete work as porch foundation; cornice board; corner boards.

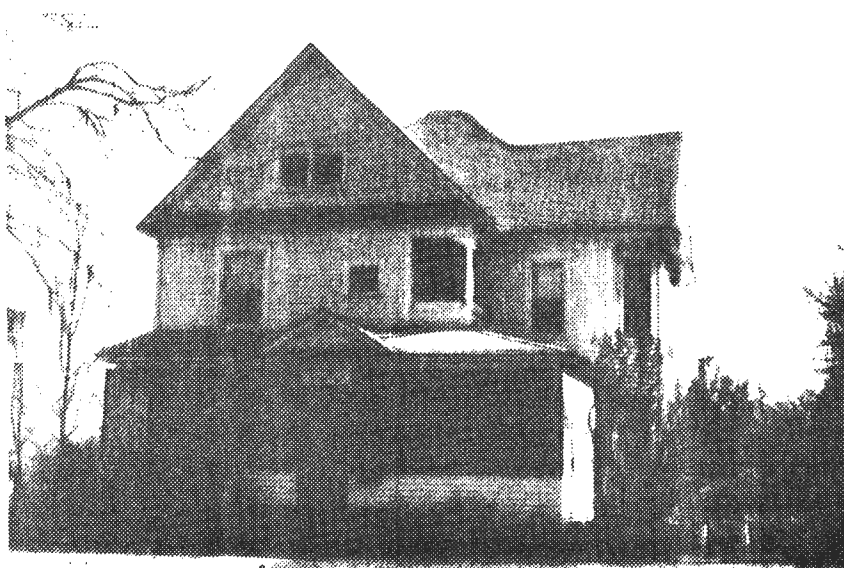
**■ IDENTIFICATION****STREET ADDRESS:** 628 - 7th Street**ORIGINAL USE:** Residence**PRESENT USE:** Residence**PUBLIC**  
**PRIVATE \***

**COMMENTS:** front porch with round Doric-like columns; gable-pediment over entry in porch roof; imbricated shingles in gables with twin windows; small 2nd story balcony with 1 column in corner; chamfered corners on W. bay with jigsaw brackets at eave; plain frieze under continuous eave across gables; corner pilasters; molded heads over openings; hipped dormer at E. side; rear porch with spindle columns.

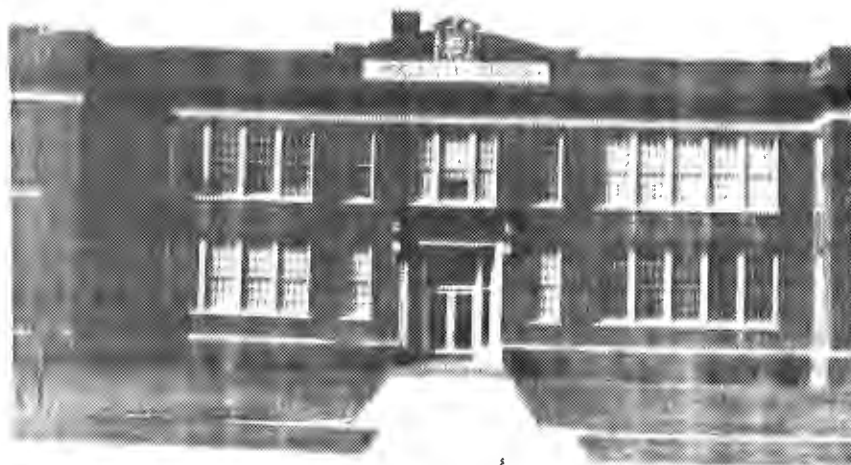
**STREET ADDRESS:** 921 - 9th Street  
**ORIGINAL USE:** Public school  
**PRESENT USE:** Public school

**THREATS TO STRUCTURE:** brick parapet and some sections of wall show stress cracks.
